Flightfax®

Online Report of Army Aircraft Mishaps

Mishap Review: NVG Multi-ship AASLT

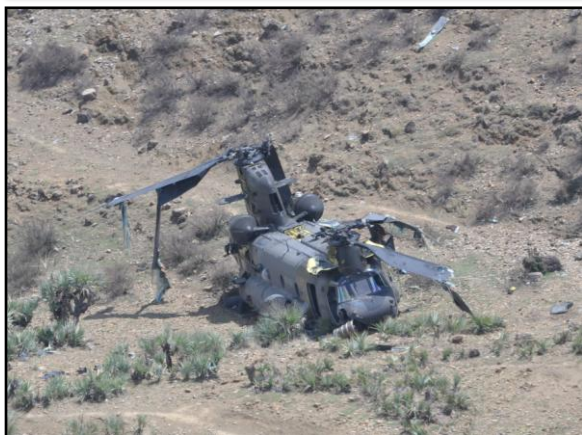
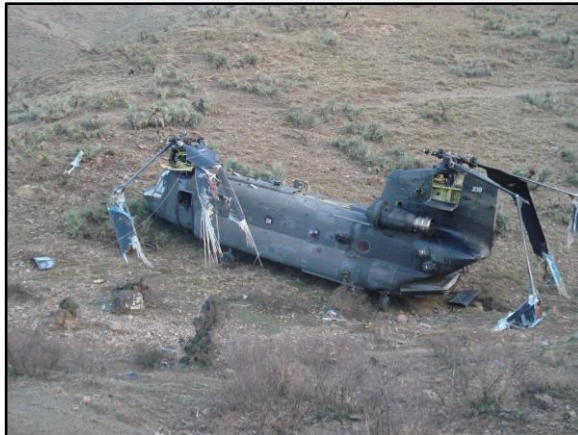
While conducting a hasty air assault under NVG conditions, the CH-47D forward rotor blades contacted rising terrain during an upslope landing. The front rotor disk became unbalanced and desynchronized the rotor system causing significant aircraft damage and four minor injuries.

The accident board determined that during the upslope landing in the LZ, the pilot on the controls unintentionally activated the CMWS causing numerous flares to deploy creating a distraction during the NVG operation. The PI reacted by displacing the cyclic control forward, resulting in the forward rotor disk contacting the ground. The rotor system became unbalanced and desynchronized, causing significant aircraft damage and four minor injuries. The pressing of the flare dispenser control switch was the result of a negative habit transfer between the UH-60 trim and CH-47D CMWS cyclic switch positions. Additionally, the board noted the crew failed to safe the CMWS IAW the Aircrew Procedures Guide. During the landing sequence, the passengers removed their restraints prior to the completion of the landing without direction from a member of the crew. As a result, they suffered minor injuries when they were tossed about in the cargo area during the crash sequence.

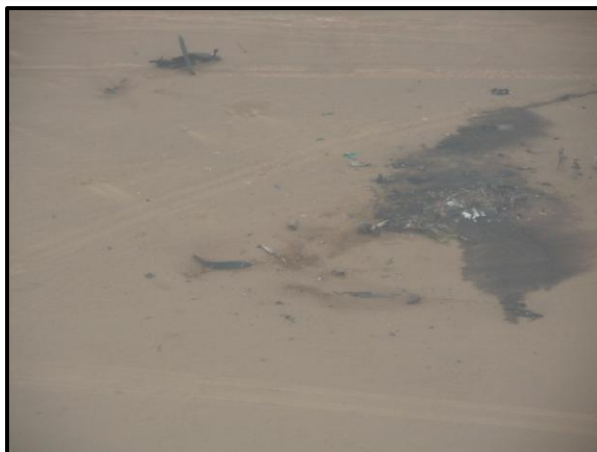
Shortly after takeoff on a night MEDEVAC chase mission, the crew of the UH-60L initiated a gradual left- hand turn. The left roll progressed past 90° and the nose pitched down. The crew was unable to regain control of the aircraft. It struck the ground, fatally injuring all crewmembers.

The accident board determined that under conditions of degraded visibility, low illumination and low contrast terrain, the pilot in command (PC) became spatially disoriented when he unknowingly initiated a gradual left turn that progressively steepened until the aircraft was in a 110 degree left bank with a nose low descent at

an altitude where a successful recovery was not possible. The aircraft impacted the ground, fatally injured the four crew members and destroyed the aircraft. The PC's lack of recent experience flying instruments and hood as well as limited NVG flight time in the previous few months were considered factors in the accident. Additionally, a lack of crew coordination in areas of communicating positively and offering assistance were noted. The aircrew was accustomed to flying during greater illumination. Therefore, flying during zero illumination over an area of low contrast and definition caused a breakdown in the aircrew's performance which led to the aircrew not positively communicating about the flight conditions or a plan of action to address the conditions. The board also suspected the TTP of flying 10 or more rotor discs separation in the encountered flight conditions made it difficult for the accident PC to maintain visual contact with the lead aircraft, and took his attention away from the flight instruments and basic aircraft control, contributing to his spatial disorientation.
